Clutch Diagnostic Manual

Greatly improved performance and environmentally friendly

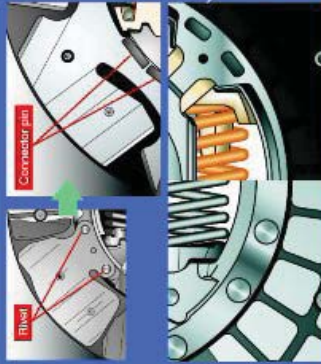
Employs single-unit disc spring assembly

NVR performance is greatly increased by positioning the coil springs at the outermost edge of the disc plate.
